Morphodynamics of Sevastopol Bays under Anthropogenic Impact

T. V. Efremova *, Yu. N. Goryachkin

Marine Hydrophysical Institute of RAS, Sevastopol, Russia

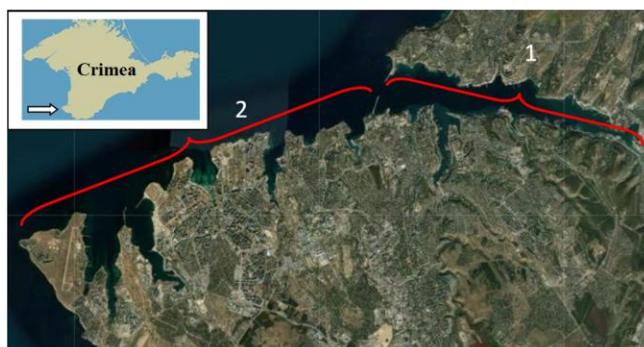
Fig. 1. Space image of the bays of Sevastopol, the numbers indicate the areas considered in the text (<https://www.google.com/intl/ru/earth/>)

The first one is Sevastopol Bay itself, currently with a total length of about 7.5 km and a perimeter length of 31.9 km from the entrance artificial piers (Fig. 1). The bay was formed due to flooding of the mouth of the Chernaya River during the post-glacial rise in sea level. The northern and southern shores of Sevastopol Bay, including Yuzhnaya Bay, were originally cliffs of Sarmatian limestone up to 30–80 feet (10–25 m) high [5]. The coastal relief is indented by gullies, which continue into smaller bays and concavities of the coastline. Before development, the coast could be attributed to the abrasion ingressive ria type. The ria type of shore, characteristic only for this region of the Black Sea, was indicated in the well-known monograph by V.P. Zenkovich¹⁾.

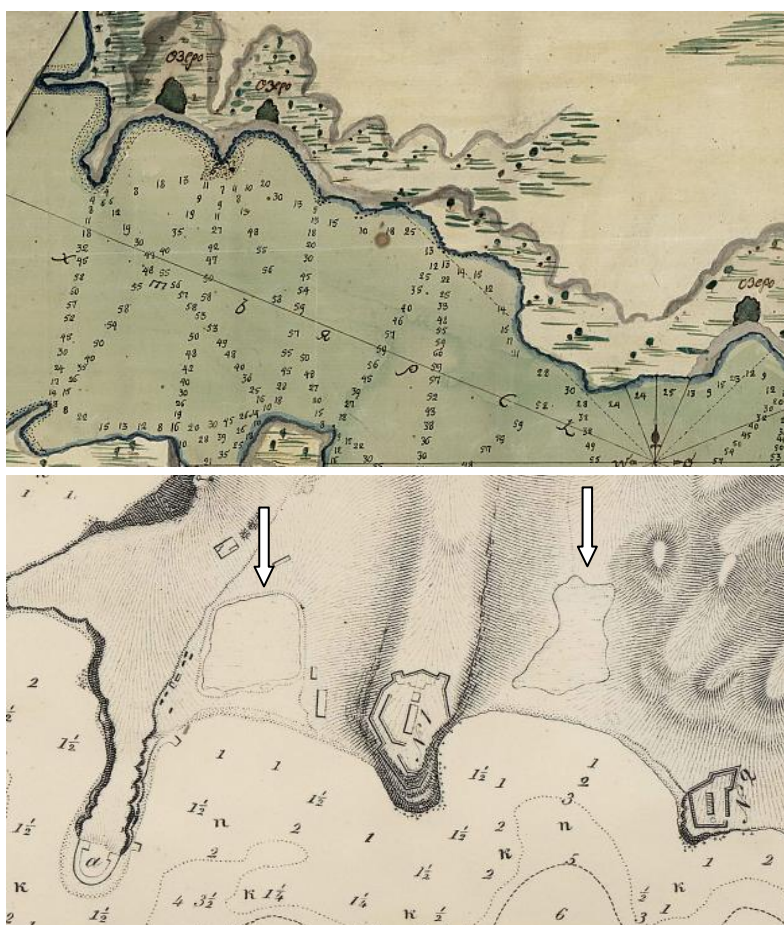
Fig. 3. A fragment of a map of the coast of the northern side of Sevastopol: *above* – on the first map by navigator Baturin (1773); *below* – on the map by navigator Radionov (1840). The arrows show the lakes

There were three lakes in the first region: two in the lowlands on both sides of the watershed between the Konstantinovsky and the Mikhailovsky forts, Konstantinovskaya and Matyushenko bays (numbers 1 and 2 in Fig. 2); the third was located in the Panayotovaya Gully (number 3 in Fig. 2). These lakes are marked on the first map of Sevastopol by navigator Baturin, 1773 (Fig. 3).

On the first map of Sevastopol mentioned above, a continuous strip of sand is marked along the coast from the Northern Spit to Matyushenko Bay (Fig. 3). It is interesting that a comparison of maps for different years shows that at present the area of the sandbar has increased, while the depths in it have decreased, which can be associated with the construction in the 1970s of a 250 m long northern pier near the Konstantinovsky Fort, which interrupted the along-shore sediment flow. It is appropriate to note here that after construction of the southern pier 500 m long, the sediment inflow into Severnaya Bay completely stopped, and the water exchange, according to some estimates, decreased by a factor of three [10]. It can be seen from the analysis of old maps that earlier accumulative forms in the shape of sandbars were present in Yuzhnaya, Aleksandrovskaya, and Martynova bays (numbers 4, 5, 6 in Fig. 2). Now fragments of these forms have remained only in Aleksandrovskaya Bay.

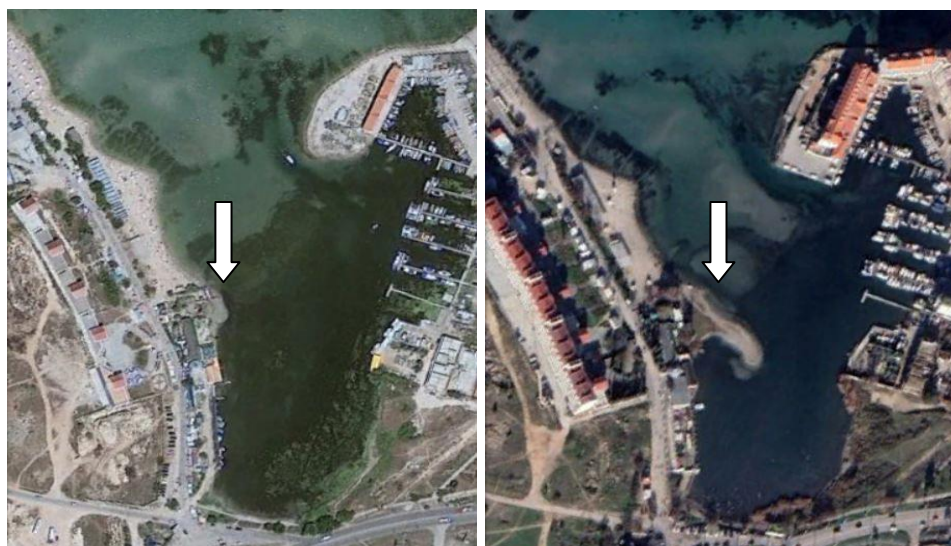
Fig. 4. The junction of the emerging sand spit on satellite images at the place of the former salt lake: *left* – 2009; *right* – 2020

In place of the former bay-bar of the southern lake, the bottom topography now represents accumulative forms in the shape of underwater sandbars composed of sandy fractions. Starting from 2015, a new bay-bar has formed to the south of the pre-existing one; at present, its length is 45 m, and its width is about 25 m (Fig. 4).

The root part of the new spit is formed 400 m south of the previously existing one. This is due to the fact that a single alongshore sediment flow in the bay was interrupted due to the construction of three buns to the north, and the source of alimentation (sand poured onto the beach before the holiday season) is located to the south of them. The sand migrates to the inner part during storms. That is, we see the desire of the lithodynamic system of Kruglaya Bay (in the presence of alimentation sources) to return to its original equilibrium state. According to the sounding data, the depths are decreasing in the apex, where the base of a small fleet is located, i.e., the process of sediment accumulation continues. At the same time, the sediment flow in the bay itself is small, as evidenced by the apparent absence of sediment accumulation from the sea near the buns. The city authorities planned to fill up the apex of the bay. It was also planned to bury the remnants of the islet to improve navigation. These plans were based on an erroneous idea of the lithodynamics of the bay.

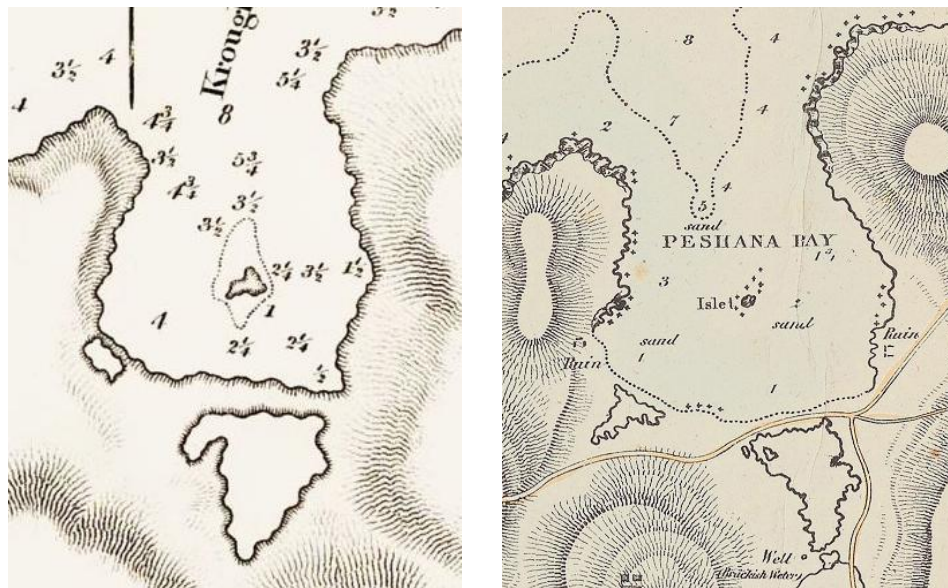
Fig. 5. An islet in the center of Kruglaya Bay on the map of 1854 (left)³⁾ and 1856⁴⁾ (right)

In the central part of the bay, there is an uplift of the bottom, which, during the period of the lowest stand of the level, protrudes above the water surface. Its length is about 150 m, its width is from 20 to 90 m. On ancient maps, this relief form was designated as a small islet (Fig. 5). By origin, it is, apparently, a remnant on which antique buildings were constructed. This was possible, since at that time the sea level was 2–3 m lower than today. This is indirectly confirmed by the presence of wave-cut niches in the western part of the bay at a depth of about 2 m, which we found during the survey of the bottom.

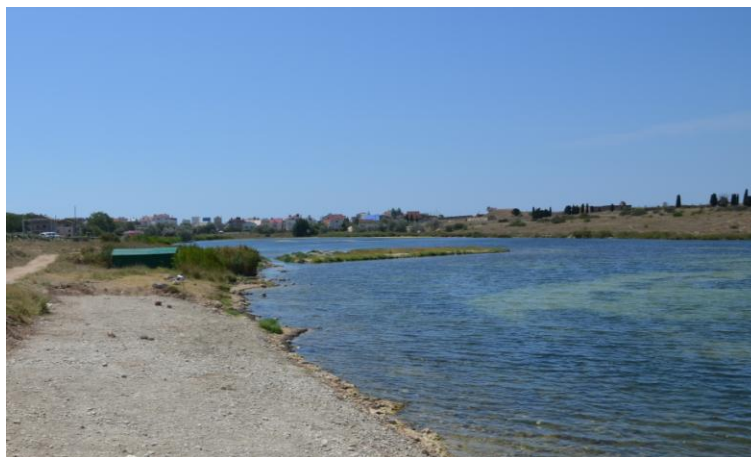
Fig. 6. The remnant of the saline lake bay-bar in Kazachya Bay

A significant salt lake existed in the apex of Kazachya Bay. According to [5], the length of the lake at the end of the 18th century was about 130 sazhen (238 m); a low bay-bar separating it was 60 sazhen long and 23 wide (110 and 49 m, respectively), of which 14 sazhen (26 m) was a flat white shore, apparently, flooded from time to time.

Further in [5, p. 41] it is noted: “In the salt lake, the bottom is as white as in the bay; the water level in it in the summer ... seemed much lower than in the bay.” The area of the lake, apparently, was about 60,000 m². A dirt road ran along the bay-bar for many years. In the 1950s, most of the bay-bar, as in Kruglaya Bay, was dismantled for construction sand. At present, a small part of the spit in the eastern part of the bay has been preserved (Fig. 6). It is composed of sand with an admixture of rounded limestone fragments. Analysis of satellite images shows the current accumulation of sediments in the area of the former bay-bar.

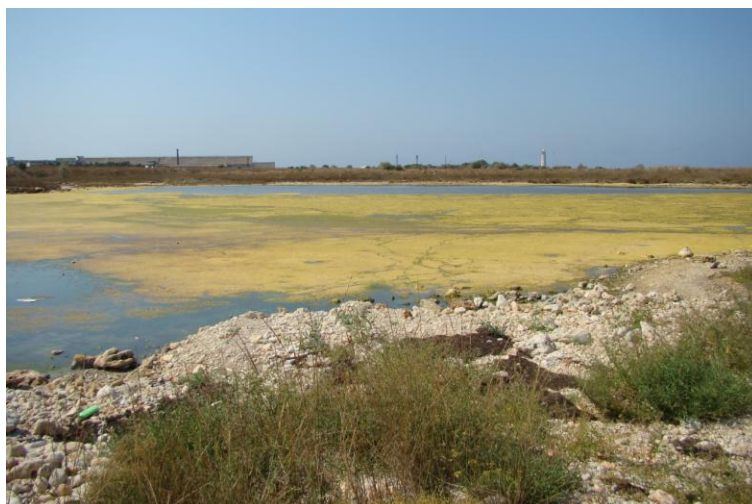
Fig. 7. The last remaining salt lake in the Sevastopol region

Finally, the only lake that has survived to this day is located near Cape Chersonesus. Here is how it is described in [5, p. 41]: “There is also a salt lake ... 60 sazhen (110 m – *Author’s note*) in length on a shovel-shaped cape, which ends Crimea in the northwest. This lake also, apparently, was part of the bay, and its bay-bar was formed by the run-up of waves that carried silt and gravel into a dam of 60 sazhen in length and about 20 in width, one height with the shore; everything is surrounded by fragments of stones, like a small rampart, so that now salt settles in this lake, separated from the sea, which, however, does not happen every year. This salt, although of poor quality because [the lake] is saturated with bitter salt, is used and taken by the Tatars from neighboring mountain villages, who are forced to take the tenth load to the owner in Akhtiar for free; the same is done with regard to the lakes of Kruglaya Bay. Several salt flats, almost dry, visible on this cape at a distance of 60 sazhen from the lighthouse, apparently, are of the same origin and are separated from the sea by coastal, low drafts, like stone walls.”

At present, the lake is double, in its southern, apex part there is one more bay-bar, both of them are composed of limestone fragments. The area of the lake is about 15,000 m², the bay-bar is 150 m long and up to 30 m wide. The landscape of the surrounding area is lacustrine-estuary with halophyte vegetation [14] (Fig. 7).

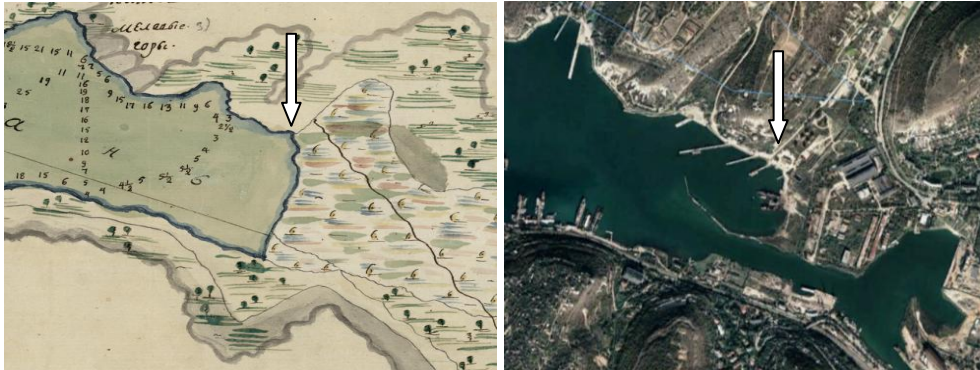
Fig. 8. The mouth of the Chernaya River: on 1773 map (left), on 2021 space image (right) (<https://www.google.com/intl/ru/earth/>)

The estuary part of the Chemaya River, flowing into Sevastopol Bay, has undergone significant transformations under the influence of anthropogenic activity. In the post-glacial period, thick marine, firth-marine and alluvial deposits formed in the sea mouth of the river. In the middle of the 19th century, the mouth of the river was a swampy area – a river delta with numerous branches. It can be seen on old maps that there was a wide bar with depths of up to 1 m on the bank of the river. An even older inner river delta, the remains of which can still be traced, was located in the area of the modern bridge. Probably, the mouth section of the river and the Inkerman estuary were flooded by the sea during the next transgression, then, as a result of filling with sediments and regression of the sea, the marine stage of development of the mouth was replaced by the estuary, and later by the river development, and the mouth acquired modern relief [16]. At present, a deep water area is located on the site of the swampy delta. The configuration of the shores has been anthropogenically changed by the construction of piers, moorings, dams and other hydraulic structures on bulk soils. The main transformations of the mouth of the Chemaya River included construction of a bucket for the Sevastopol Seaport (in Inkerman), creation of an artificial reservoir with an area of about 0.4 km² at the mouth section of the river and the site of a floodplain swamp, and digging of a navigable canal (Fig. 8). Now the territory is a continuous industrial zone. In recent years, illegal sand mining has been carried out under the guise of leveling the coastline.
