Anthropogenic Impact on the Coastal Zone of Koktebel Bay (Black Sea) over the Last 100 Years

Yu. N. Goryachkin

Marine Hydrophysical Institute of RAS, Sevastopol, Russia
e-mail: yngor@mhi-ras.ru

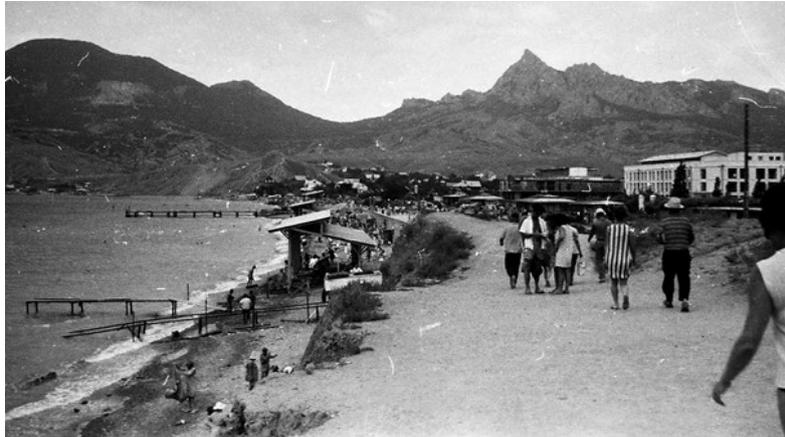
Fig. 4. A beach in Koktebel. Photo 1965

The actual volumes of extraction, which continued until 1967, are unknown (according to estimates given in [14], they amounted to 1.5 million tons). As a result, the beaches began to shrink rapidly and their width in the western part of the bay was 5–10 m by the mid-1960s, and the water edge came right up to the cliff (Fig. 4).

The beach no longer provided any damping of the wave energy of even small storms. The beaches in the eastern part of the bay also became smaller. At Junge Hill, there was no beach at all and one could pass to the other side there with the help of footbridges in the water.

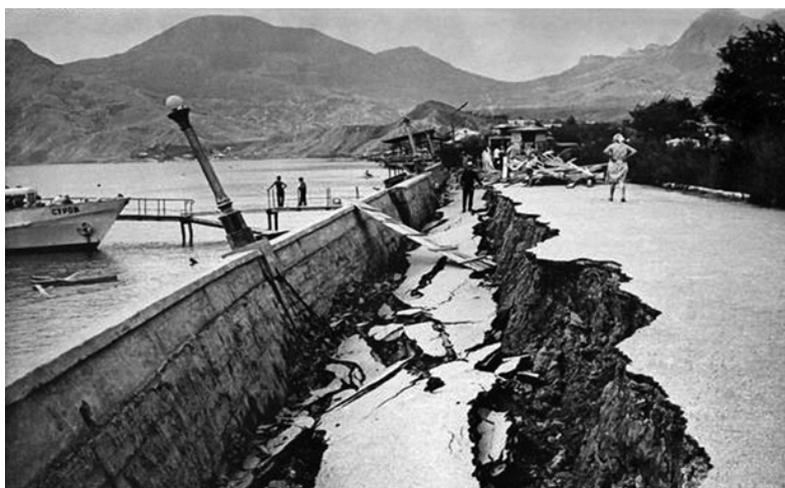
A strong storm in January 1967 washed away the remains of the beach, collapsed the retaining walls and destroyed the embankment (Fig. 5). The coast was washed away over a stretch of more than 2 km. The Koktebel beach practically ceased its existence and the buildings located behind the embankment were under threat of destruction.

Fig. 5. Consequences of the storm dated 13 January 1967. Photo 1967

In 1967, the Yalta Department of the GIPROKommunStroy Institute developed a project for emergency coastal protection measures, which envisaged partial restoration of the beaches by backfilling the water edge zone with imported material. The material was backfilled on the western wing of the bay in the amount of 150 thousand m³ in approximately equal proportions of limestone rubble from the quarry of Mount Agarmysh (near the town of Stary Krym) and granite from the Donbass deposits. Taking into account the content of clay impurities, the actual volume was about 90 thousand m³. Over 12 years, the rubble turned into pebbles. Its roundness was from 2.4 to 3.4 points on a four-point scale ⁶⁾.

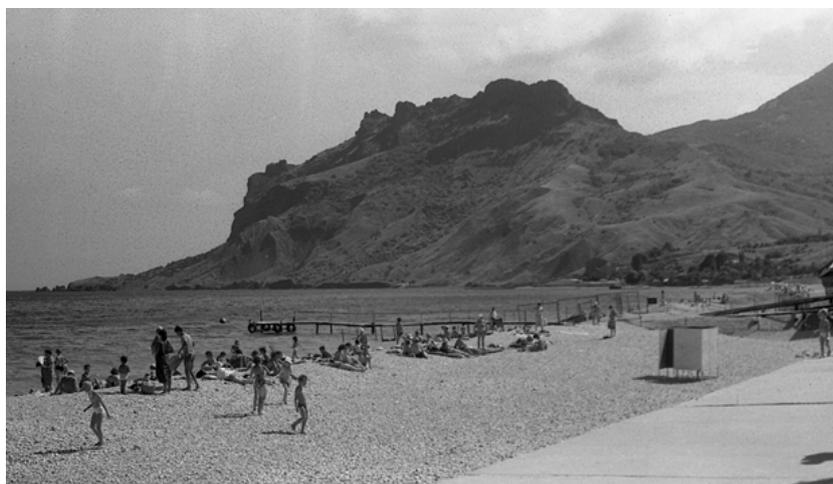
According to the 1984–1990 project of the Yalta Department of the UkrYuzhGIPROKommunStroy Institute, embankments with a stepped slope structure designed to dampen residual wave energy were built and an artificial beach was created. In addition, reserve filling of crushed stone in the amount of 144 thousand m³ was carried out in the westernmost section of the coast. The width of the beach area along the entire length of the bay was restored. In 1988, the western section of the bay represented an artificial pebble beach leaning against the foot of the coastal slope; the width of the above-water part of the beach here reached 43 m (Fig. 6).

Fig. 6. An artificial beach in the western part of Koktebel Bay. Photo 1988

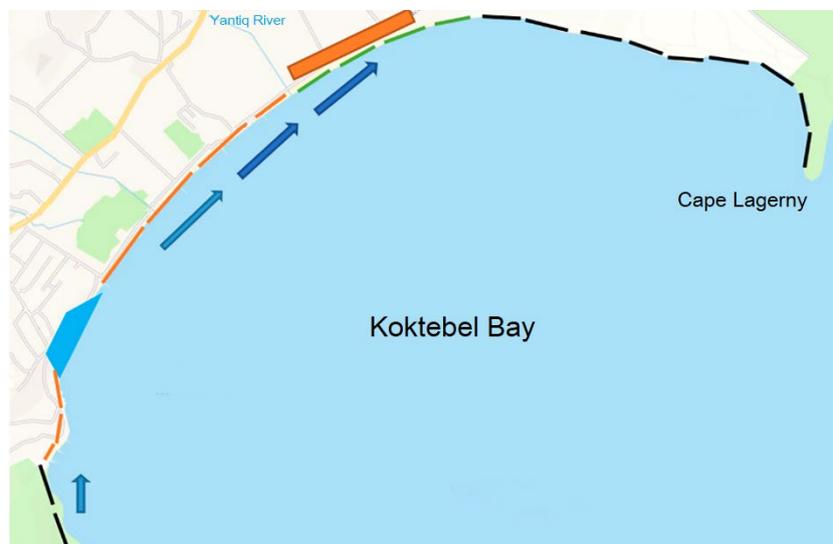
Fig. 7. Lithodynamics diagram. Black dashed line – areas of abrasion, orange one – coast retreat, green one – a relatively stable coast. Orange rectangle – place of sand extraction, blue trapezoid – place of reserve filling. Arrows – average long-term direction of sediment movement

a vertical wall was erected. Here, part of the embankment was expanded by means of a stepped slope structure – a vertical reinforced concrete wall was erected along the abutment of the flight slabs, the sinus was filled with soil, a concrete covering was installed and later concrete tiles were laid on top of the concrete. The vertical wall installed instead of the existing slope structure contributed to the degradation of the beach, which subsequently led to its erosion and destruction. In the central part, to the west of the Voloshin House Museum, two platforms protruding into the sea were built illegally. Such transverse structures represent an obstacle to the existing flow of sediments and cause the accumulation of beach material in front of the structure and erosion behind the structure (in the direction of the flow). By 2009, this process had already been quite pronounced. Since the sediment flow is directed toward the center of the bay, the width of the above-water part of the beach northeast of the above mentioned platforms (in the area of the Voloshin House Museum) has decreased by 6–8 m in two years since the start of construction of the sites (2006); at the same time, beach material accumulated to the southwest. The structures built in the waterfront zone and extended into the sea prevented the natural movement of material and they were subjected to the intense wave action, as a result of which some of them were destroyed (Fig. 7).

Altogether, the general nature of the lithodynamic processes occurring in the bay remained unchanged throughout the 1990s and 2000s: the beach remained fairly stable in the central part of the bay; seasonal changes in the width of the above-water part of the beach were within 5 m with a beach width of up to 45 m; steady degradation of the beach was observed in the southwestern part (the reserve filling area).

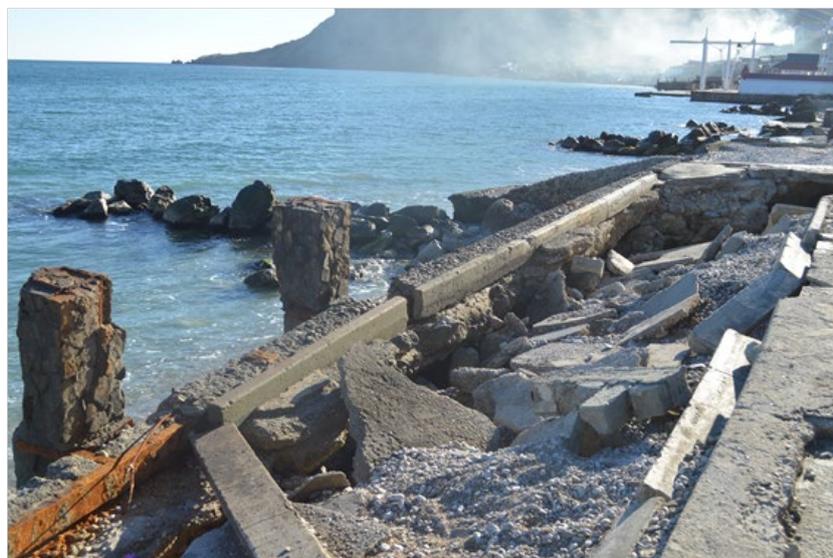
Fig. 8. Reserve filling area. Photo 2021

When the Autonomous Republic of Crimea was a Ukrainian region, applications were repeatedly sent to administrative bodies indicating the inadmissibility of construction on the reserve filling area and the inevitability of the destruction of the constructed structures, but no effective measures were taken (Fig. 8).

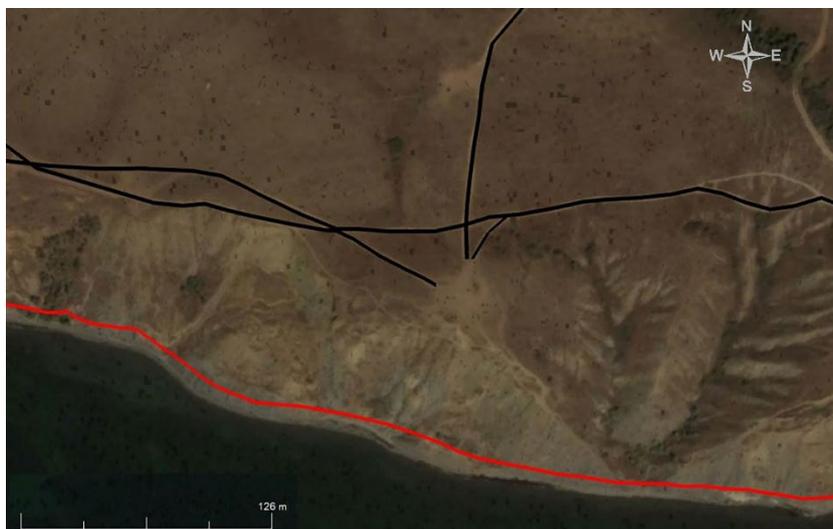
Fig. 9. Satellite image of the eastern part of Koktebel Bay in the area of the observation deck (September 2011). Red line – coastline in August 2021. Black lines – roads in August 2021

Further east, to Junge Hill and further east, the width of the above-water part of the beach ranged from 33 to 42 m according to a 2009 survey and satellite images. During this time, the width of the beach changed insignificantly (1–2 m). By 2021, the configuration of the coastline and the width of the beaches had hardly changed.

Further east, right up to the beginning of the cliff, the beach has gradually decreases. Its width and configuration of the coastline remained almost unchanged over the period 2009–2021 according to satellite images and survey materials from November 2021. In the area of the beginning of the cliff, the beach width in 2021 was 12 m, which corresponds to the 2021 image. Further east, over a distance of 1 km, the abrasion coast in 2011–2021 retreated at an average rate of 0.7 m/year (Fig. 9). The rate of retreat of the coastline of the western part of Cape Lagerny during the same period was two times less – about 0.3 m/year.
