Transformation of the Lake Bogaily Barrier Beach (Western Crimea) under the Influence of Extreme Storms

For citation: Krylenko, V.V., Goryachkin, Yu.N., Krylenko, M.V. and Divinsky, B.V., 2024. Transformation of Lake Bogaily Barrier Beach (Western Crimea) under the Influence of Extreme Storms. *Ecological Safety of Coastal and Shelf Zones of Sea*, (3), pp. 59–78.

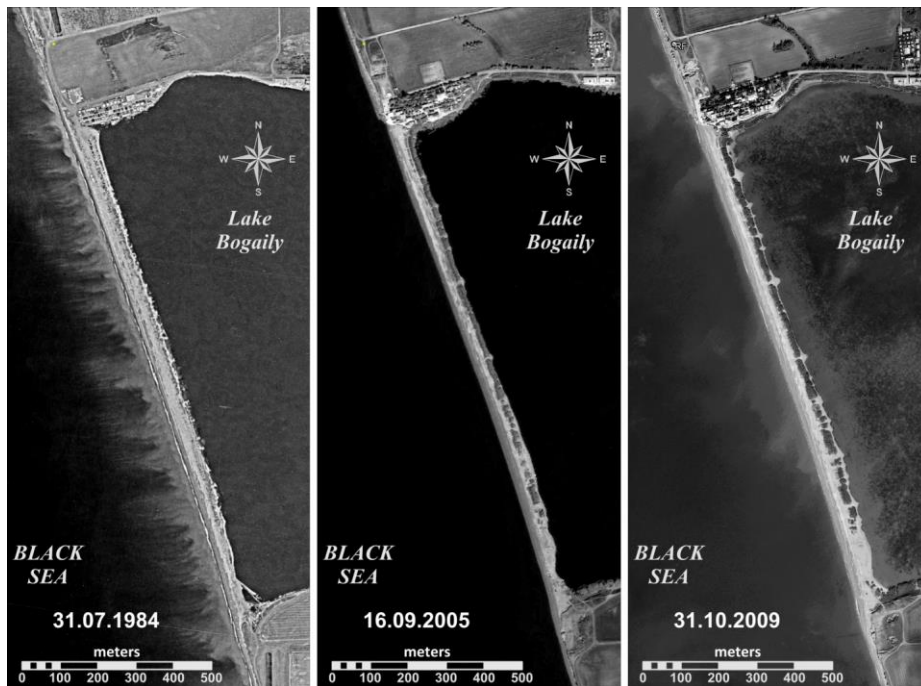
Fig. 3. Development of the Lake Bogaily Barrier Beach in 1984–2009

The image dated 31 July 1984 (Fig. 3) illustrates the restoration of the barrier beach structure in the form of a beach strip, a dune ridge with developed lagoonal slope vegetation, and a drying strip with emergent vegetation along the lakeshore. The width of the barrier beach varies from 40 m in the southern part to 60 m in the northern part. The seaward edge line is almost straight, with a few gentle bends in the southern part of the lake edge line. Trails traversing the dune and vegetative bands are discernible, yet there is no indication of substantial transverse scouring or evidence of drift cone formation along the lakeshore.

The configuration of the barrier beach (Fig. 3) in the 2005 image is very similar to that observed in 1975, showing a levelled sea-front line and a curved lake-front line. The width of the barrier beach at two-thirds of the northern extent is approximately 50 m, subsequently increasing to 60 m. Thereafter, at approximately 100 m from the southern boundary, there is a notable narrowing to 30 m. In the longitudinal structure, the strip of beach, dunes and adjacent vegetation is clearly discernible. The width of these zones along the barrier beach varies in a gradual manner without exhibiting abrupt changes. The 08 May 2005 image also displays transverse scour holes that separate the vegetation strip. The largest of these holes on the lagoonal shore correspond to export cones. The general configuration of the sea and estuarine banks in the image dated 31 October 2009 (Fig. 3) has remained largely unchanged in comparison with the image dated 08 May 2005. However, the export cones are now much more visible and are present at the majority of scour holes. It can thus be concluded that the extreme storm of November 2007 did not have a significant impact on the morphological structure of the Lake Bogaily Barrier Beach. Rather, its impact was limited to the expansion of scour holes and export cones. As illustrated in Fig. 4, the aforementioned structure was largely preserved until the November 2023 storm.

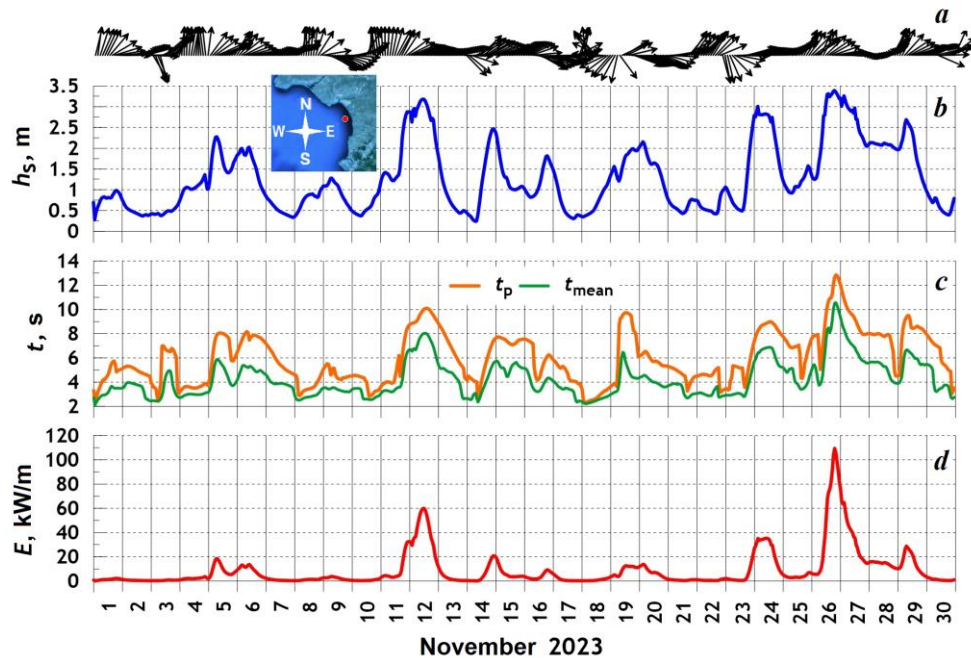
Fig. 7. The main parameters of wind waves near the Lake Bogaily Barrier Beach: *a* – propagation directions; *b* – significant wave heights; *c* – peak and mean wave periods; *d* – wave power

Fig. 7 shows a series of significant wave heights, periods, strengths and directions at the Lake Bogaily Barrier Beach for November 2023. It shows that the Lake Bogaily Barrier Beach was under the influence of developed wave action for almost the entire month. Three storms with power greater than 30 kW/m were observed, including an extreme storm on 26–27 November. As shown in Fig. 6, *b*, this storm is the strongest in terms of power (109 kW/m) for the Lake Bogaily Barrier Beach in the last 45 years. Previously, the strongest storm was the storm of 2000 (82 kW/m). At the time of the largest storm development on 26 November 2023 at the isobath of 10 m near the Barrier Beach of Lake Bogaily, the wave parameters were as follows: significant wave height – 3.4 m, period – 12.8 s, length – 160 m. The surge height during the storm was 0.21–0.54 m.

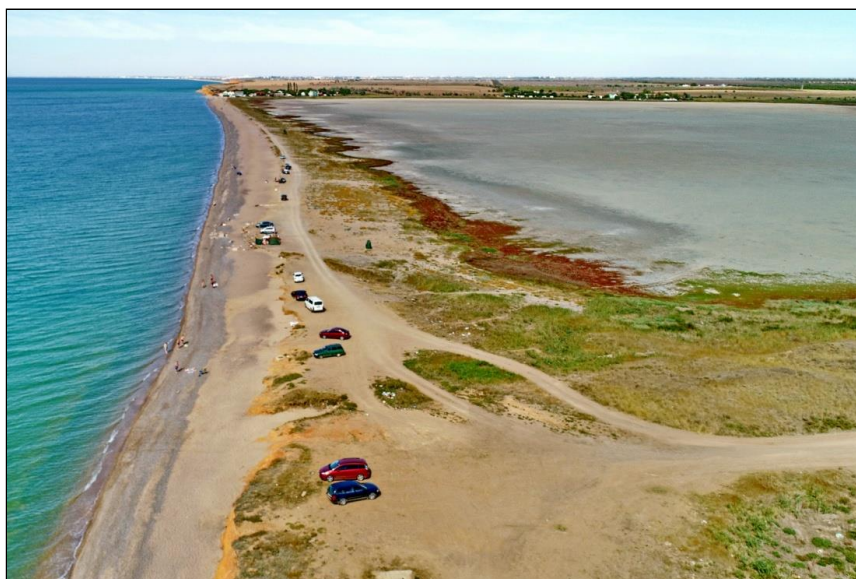
Fig. 9. View of the Lake Bogaily Barrier Beach from the south side (2021)

The storm surge covered even the highest parts of the barrier beach and destroyed pre-existing landforms. The storm surge completely destroyed the characteristic longitudinal structure that had existed for several decades, including bands of dunes and vegetation (Fig. 9). In essence, the former orderly longitudinal and transversal structure that had been formed and maintained over decades was transformed into a full profile beach with steep marine and gentle lagoonal slopes.
