Anthropogenic Impact on the Lithodynamics of the Black Sea Coastal Zone of the Crimean Peninsula

Yu. N. Goryachkin, T. V. Efremova*

Marine Hydrophysical Institute of RAS, Sevastopol, Russia

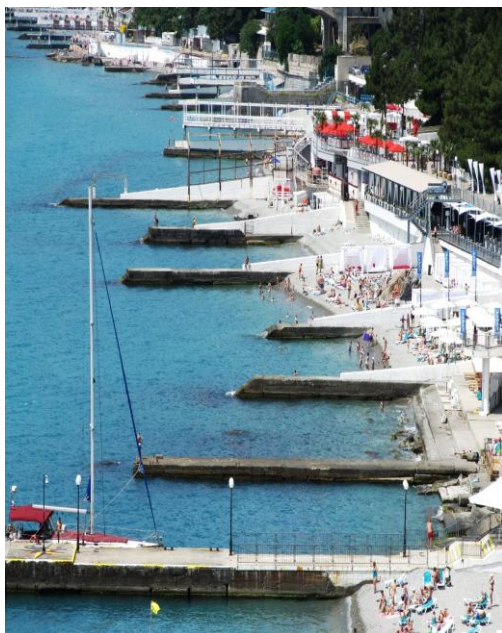
Fig. 1. Anthropogenic coast on the SCC

The high degree of anthropogenic pressure on SCC has already been noted above. To date, almost the entire coast, with the exception of hard-to-reach areas, is filled with concrete structures, more than 600 groins have been built. The technogenic load factor $K = l/L$ (where l is the linear dimensions of structures; L is the coast length) on the coast between Cape Sarych and Alushta (about 75 km) is 1.2, which is an extreme value according to the classification given in [26]. Undoubtedly, coast protection works built in the 1970s–1980s of the last century reduced the risk of landslide, expanded the areas of beaches and adjacent territories, but also created problems [27].

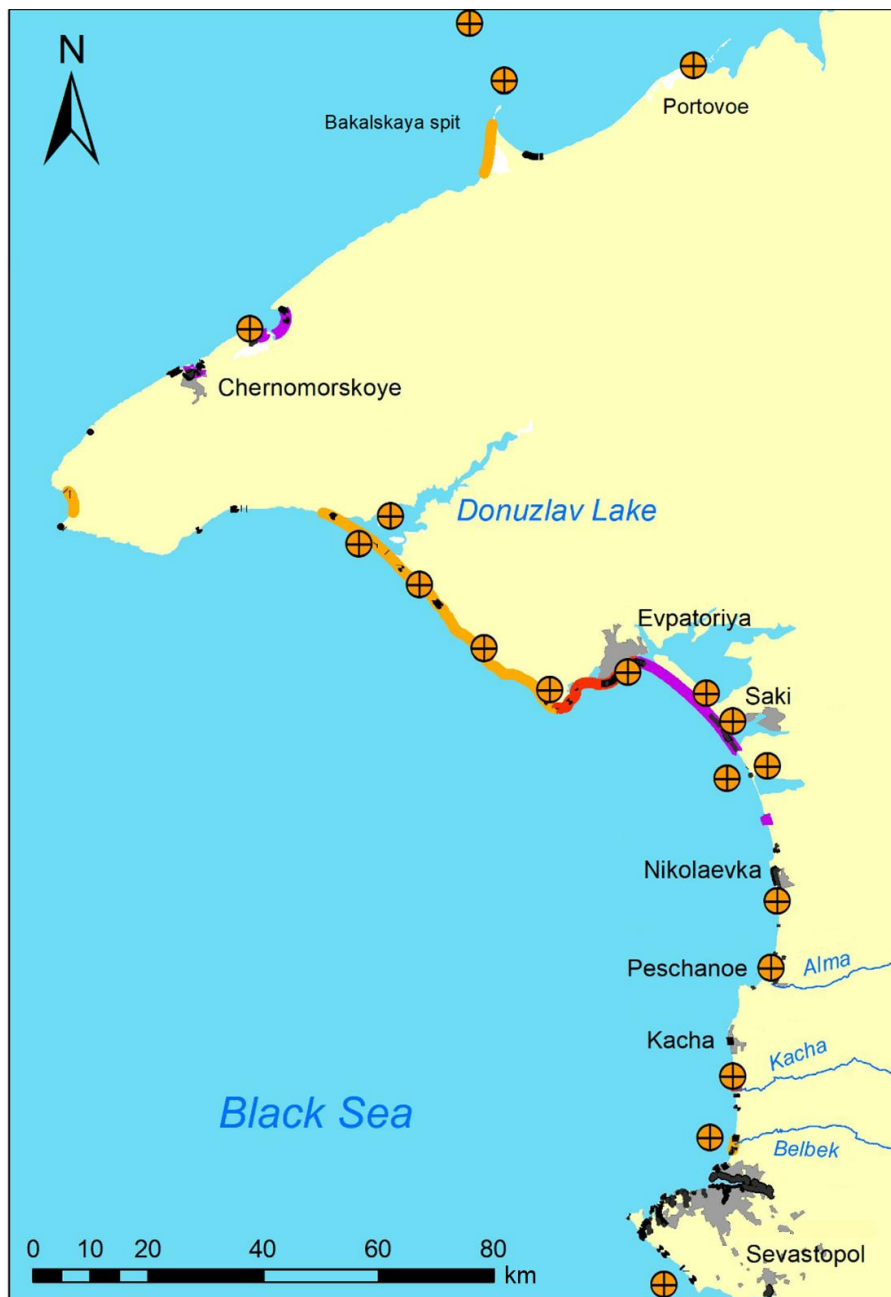
Fig. 2. Negative effect on lithodynamics of the coastal zone (slightly transformed dunes – orange lines, significantly transformed dunes – purple lines, destroyed dunes – red lines); circles – sand extraction on an industrial scale; black spots denote permanent facilities on the beaches

It is not surprising that vacationers and investors are increasingly paying attention to the coast of Western Crimea, where the anthropogenic load is still not so great (Fig. 2). At the same time, it is important to avoid the mistakes that were made here earlier, in the 1970s–1990s. They were caused by the desire to ennoble the coast with artificial structures using standard solutions that had already been tested in the SCC but did not take into account fundamentally different features of the lithodynamics of the coastal zone of Western Crimea. In fairness, it should be noted that incomplete implementation of design decisions also played a role.

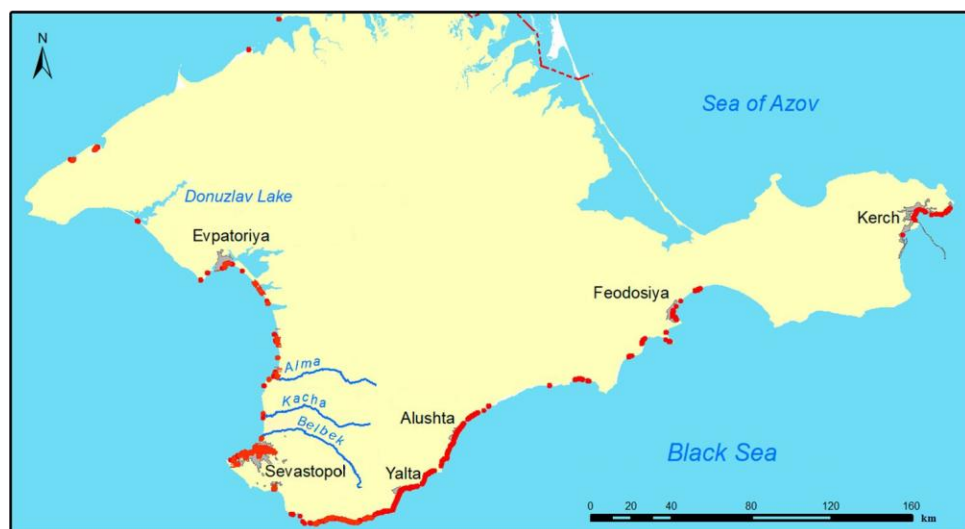
Fig. 4. Coast protection structures

water edge. After the construction, the sandy beaches that had existed here before completely disappeared. If earlier the bottom of the western part of the bay was composed of yellow biogenic sand, later, according to the survey data of 2012, it was covered with gray-black silty sand and heavy growth of *Zostera marina*. Currently, the dilapidated embankment is being reconstructed together with an artificial pebble beach. Thus, in Evpatoriya, as a result of the construction of hydraulic structures, the beaches completely disappeared over 3 km and significantly decreased over 2.5 km. Locations of the coast protection works of the Crimea are shown in Fig. 4.

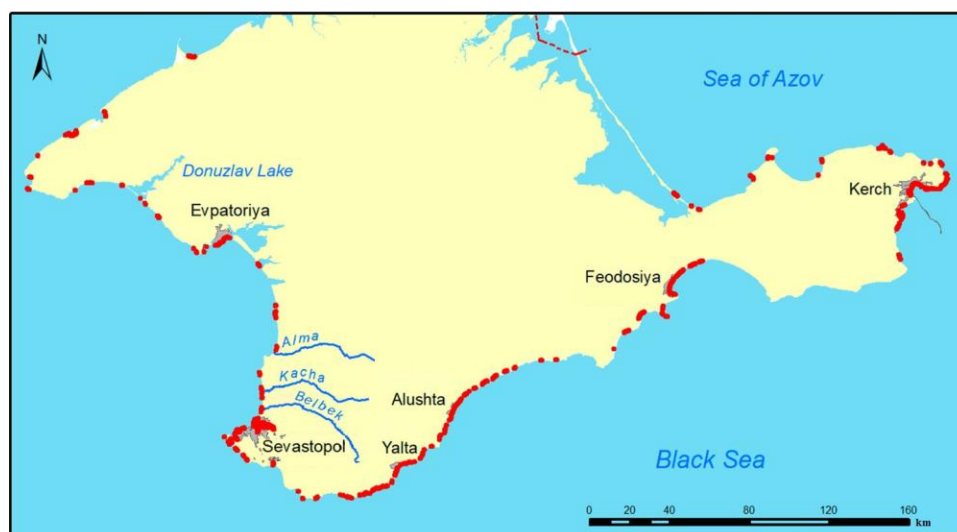
Fig. 5. Permanent facilities on beaches

Permanent construction on the beaches (mainly of recreational facilities), despite legal prohibitions in the USSR, Ukraine and the Russian Federation, and its obvious negative impact on the coastal zone has been and remains a common practice. The objects are documented as coast protection works with rest rooms, fishing boxes, rescue stations, reading rooms, etc. A map presenting the location of the largest works is shown in Fig. 5. According to it, most of them are situated on the SCC, but there are enough of them in other resort areas. Let us give some more examples.

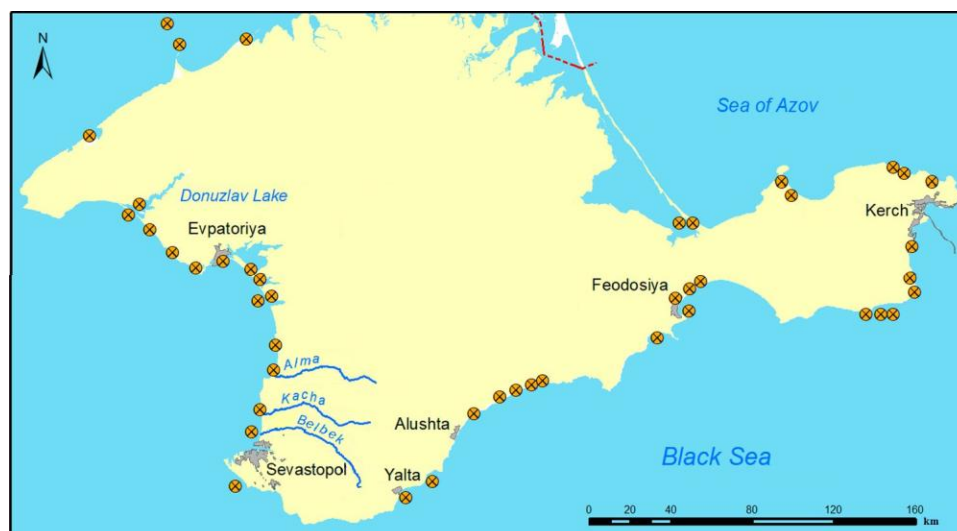
Fig. 6. Proved sites of extraction of inert materials on an industrial scale

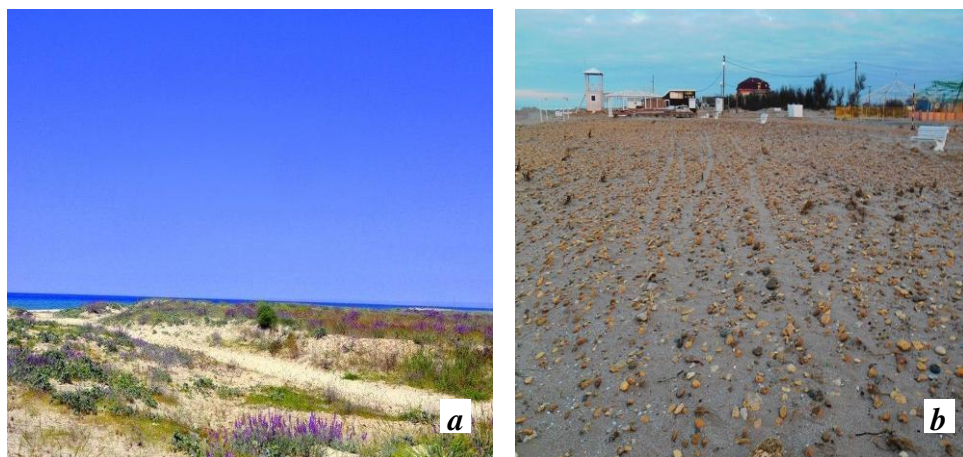
Fig. 7. Dunes before (a) and after (b) planning of the beach in the vil. of Shtormovoe
