## Anthropogenic Impact on the Coastal Zone of Koktebel Bay (Black Sea) over the Last 100 Years

Yu. N. Goryachkin

*Marine Hydrophysical Institute of RAS, Sevastopol, Russia*  
*e-mail: yngor@mhi-ras.ru*

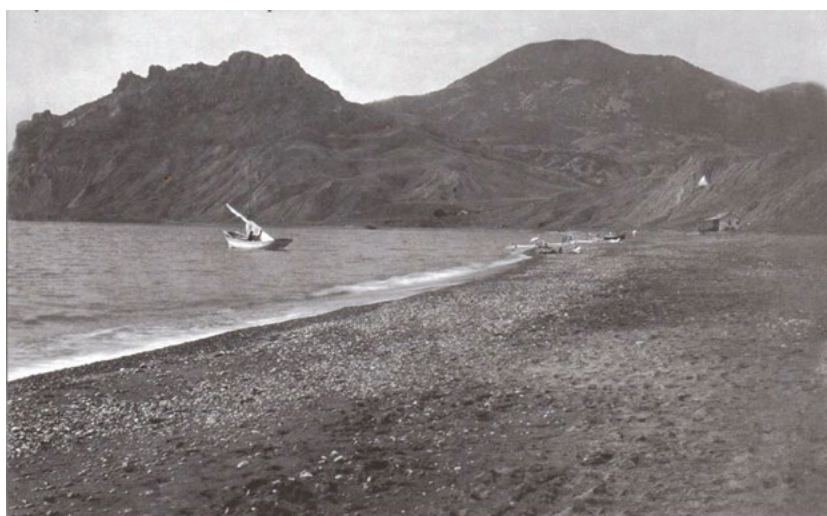
Fig. 3. View of the western part of Koktebel Bay, photo 1914

At the beginning of the 20th century, the shores of Koktebel Bay were a sparsely populated area. Old photographs show no significant construction (Fig. 3).

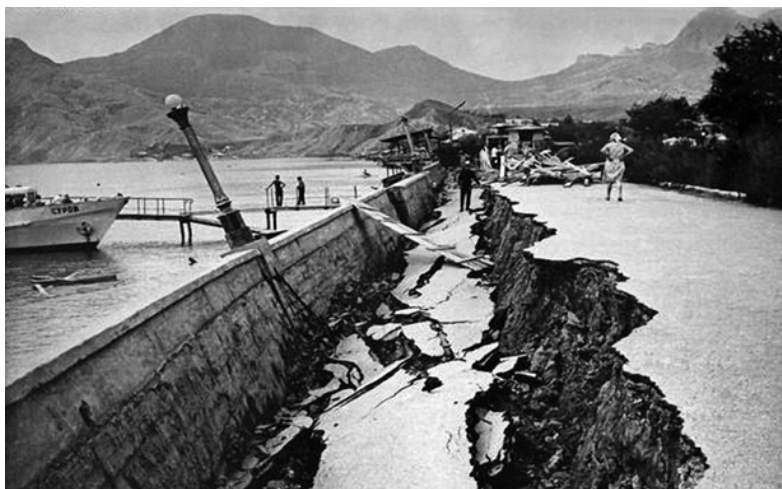
Fig. 5. Consequences of the storm dated 13 January 1967. Photo 1967

A strong storm in January 1967 washed away the remains of the beach, collapsed the retaining walls and destroyed the embankment (Fig. 5). The coast was washed away over a stretch of more than 2 km. The Koktebel beach practically ceased its existence and the buildings located behind the embankment were under threat of destruction.

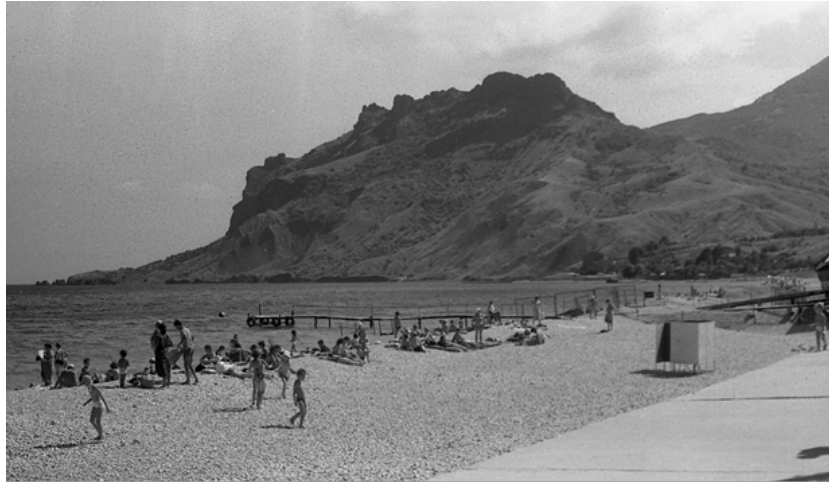
Fig. 6. An artificial beach in the western part of Koktebel Bay. Photo 1988

According to the 1984–1990 project of the Yalta Department of the UkrYuzhGIPROKommunStroy Institute, embankments with a stepped slope structure designed to dampen residual wave energy were built and an artificial beach was created. In addition, reserve filling of crushed stone in the amount of 144 thousand m<sup>3</sup> was carried out in the westernmost section of the coast. The width of the beach area along the entire length of the bay was restored. In 1988, the western section of the bay represented an artificial pebble beach leaning against the foot of the coastal slope; the width of the above-water part of the beach here reached 43 m (Fig. 6).

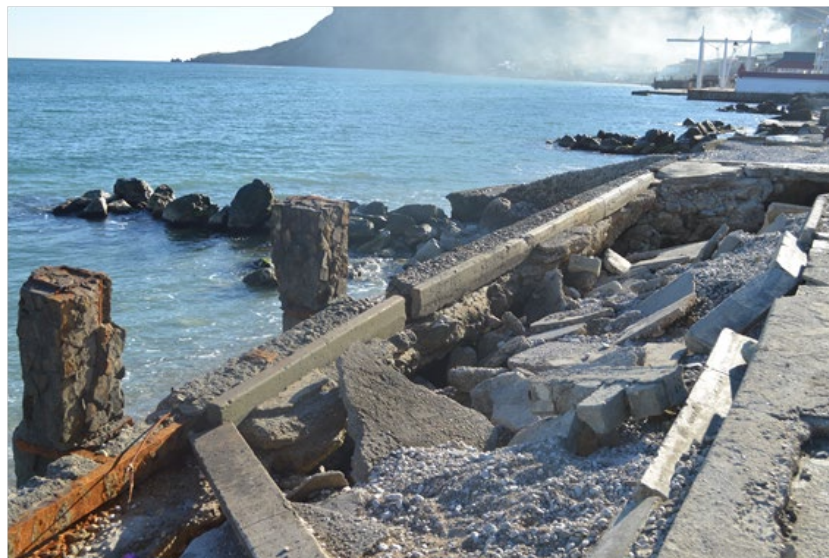
Fig. 8. Reserve filling area. Photo 2021

When the Autonomous Republic of Crimea was a Ukrainian region, applications were repeatedly sent to administrative bodies indicating the inadmissibility of construction on the reserve filling area and the inevitability of the destruction of the constructed structures, but no effective measures were taken (Fig. 8).

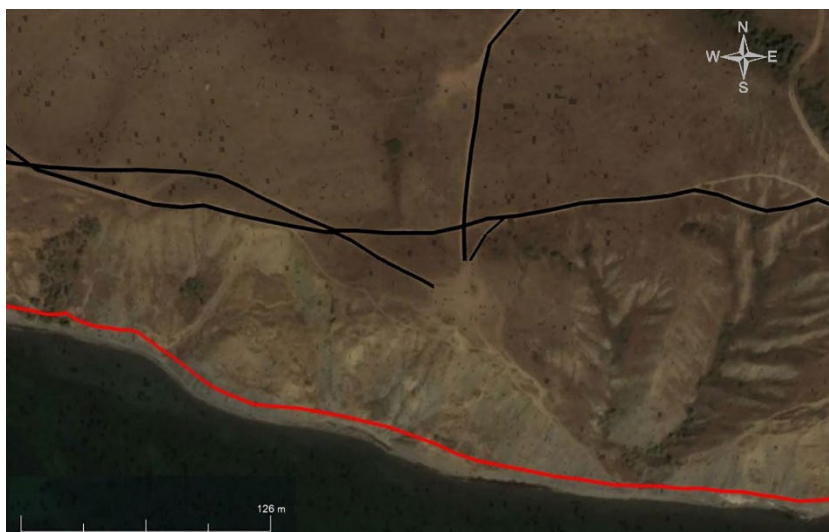
Fig. 9. Satellite image of the eastern part of Koktebel Bay in the area of the observation deck (September 2011). Red line – coastline in August 2021. Black lines – roads in August 2021

Further east, right up to the beginning of the cliff, the beach has gradually decreases. Its width and configuration of the coastline remained almost unchanged over the period 2009–2021 according to satellite images and survey materials from November 2021. In the area of the beginning of the cliff, the beach width in 2021 was 12 m, which corresponds to the 2021 image. Further east, over a distance of 1 km, the abrasion coast in 2011–2021 retreated at an average rate of 0.7 m/year (Fig. 9). The rate of retreat of the coastline of the western part of Cape Lagerny during the same period was two times less – about 0.3 m/year.
