## Current State and Dynamics of the Western Crimean Bay-Bars

Yu. N. Goryachkin<sup>1, 2</sup>

**For citation:** Goryachkin, Yu.N., 2025. Current State and Dynamics of the Western Crimean Bay-Bars. *Ecological Safety of Coastal and Shelf Zones of Sea*, (4), pp. 6–32.

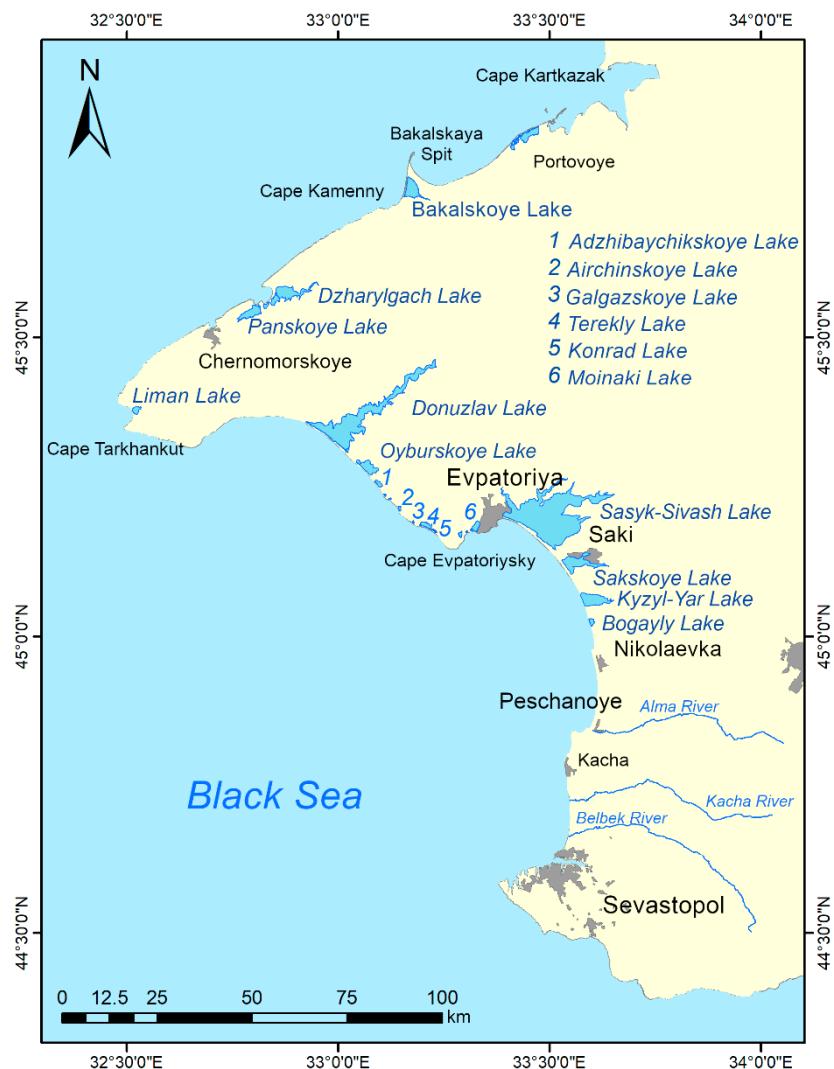
Fig. 1. Major salt lakes of Western Crimea and their bay-bars

In Western Crimea, bay-bars are typical of the North-Western, Tarkhankut and Evpatoriya sectors [3]. In the North-Western sector, they occupy ~ 10 km of the coastline; in the Tarkhankut sector, they are localised to three bays; and in the Evpatoriya sector, they account for around half of the entire 42 km coastline (Fig. 1).

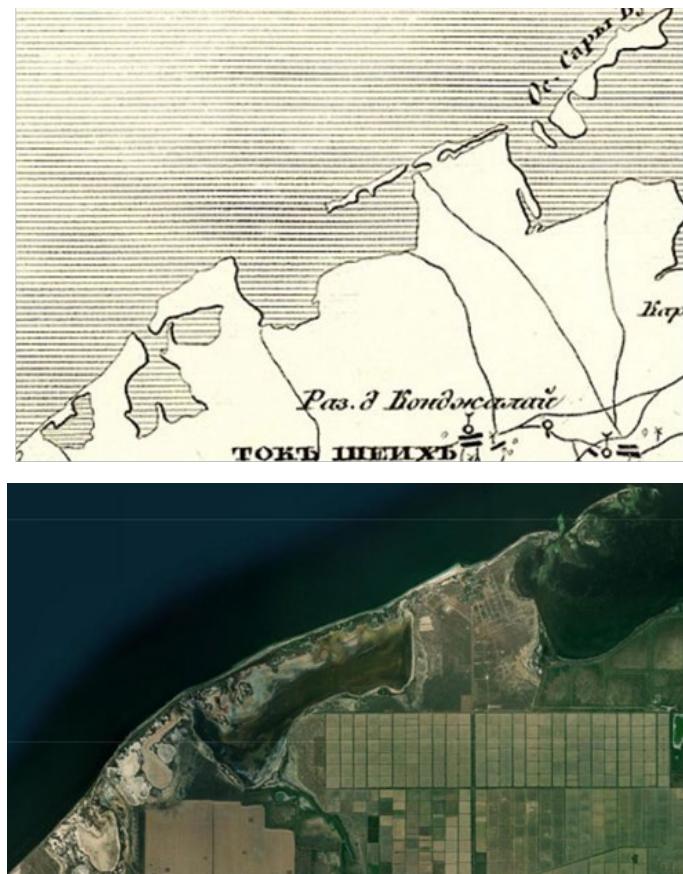
Fig. 2. Andreevsky Lagoon and Sergeevskaya Spit (bay-bar) on a map of 1842<sup>12)</sup> (top) and a satellite image (July 2024) (bottom)

To the southwest of the Lebyazhyi Islands, the coast is low-lying and accumulative, of lagoon type. These accumulative landforms are predominantly composed of whole and fragmented shell material. This coastal segment is characterized by both cross-shore and longshore (northeastward) transport of detrital-shell sediments. The most notable recent event in this area is the formation of a new bay-bar. Historical maps dating back to 1817 clearly show the progressive separation of small lagoons, formation of bar-bays, an increase in the number of Kondzhalayskie islets and the growth of the Sergeevskaya Spit. This spit eventually transformed a marine bay into the Andreevsky Lagoon<sup>11), 12), 13), 14), 15), 16)</sup> (Fig. 2).

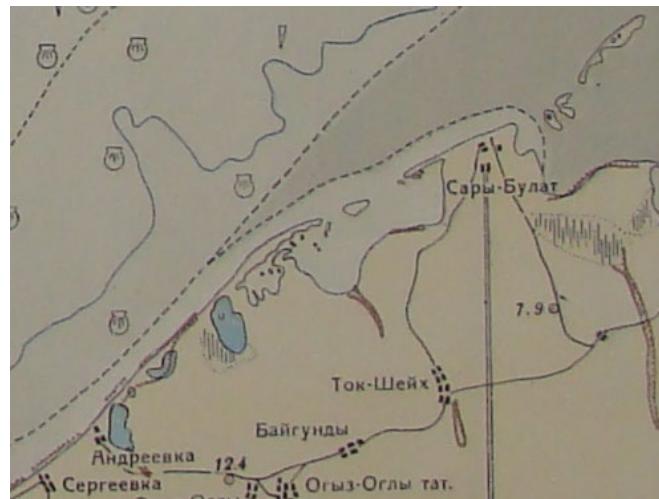
Fig. 3. Disappeared villages of Sergeevka and Andreevka on the map<sup>18)</sup>

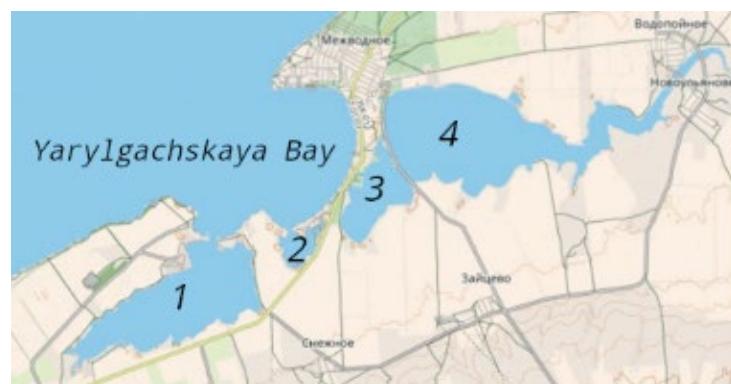
Fig. 4. Yarylgachskaya Bay. The numbers denote salt lakes: Panskoye (1), Karlav Lagoon (2), Yarylgach (3) and Dzharylgach (4)

Yarylgachskaya Bay has the most complex configuration of marine accumulative landforms, with a shoreline length of  $\sim 9$  km. Here, a sandy bay-bar separates three salt lakes, Dzharylgach, Yarylgach (Karlav) and Panskoye (Sasyk), and the Karlav Lagoon (Maloye Solenoye) from the sea (Fig. 4).

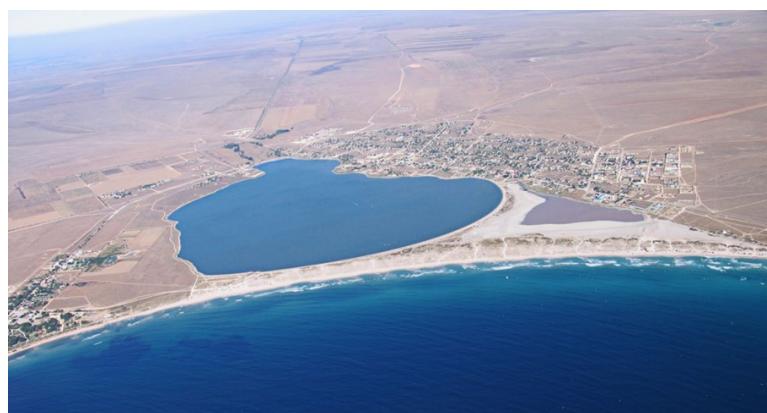
Fig. 5. Lake Liman (Karadzhza) on a quadcopter image

Satellite imagery from the last twenty years shows that, despite seasonal fluctuations, the shoreline of the bay-bar has remained stable. This finding is corroborated by direct observations conducted between 1960 and 1994<sup>19)</sup>. Unlike two bays previously discussed, the sandy dunes on the Karadzhinskaya Bay-Bar remained in relatively good condition until recently. However, under the current intensive development project for the bay, the dunes are scheduled for removal and replacement with tiles. Overall, only one-third (55,000 m<sup>2</sup>) of the existing 165,000 m<sup>2</sup> beach

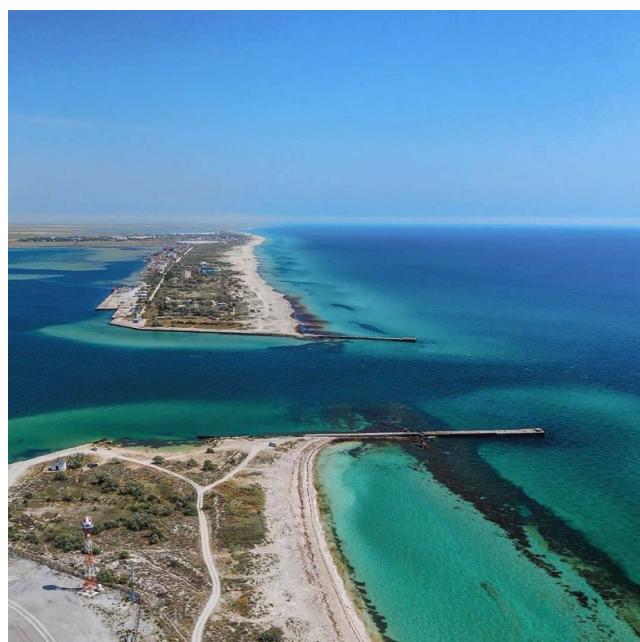
Fig. 6. Quadcopter view of the northern (at the foreground) and southern spits of the Donuzlav Bay-Bar

At the end of 1961, a 200 m wide canal was excavated through the bay-bar and two protective groynes were built to guard the entrance. This divided the bay-bar into two spits: a southern one and a northern one (Fig. 6).

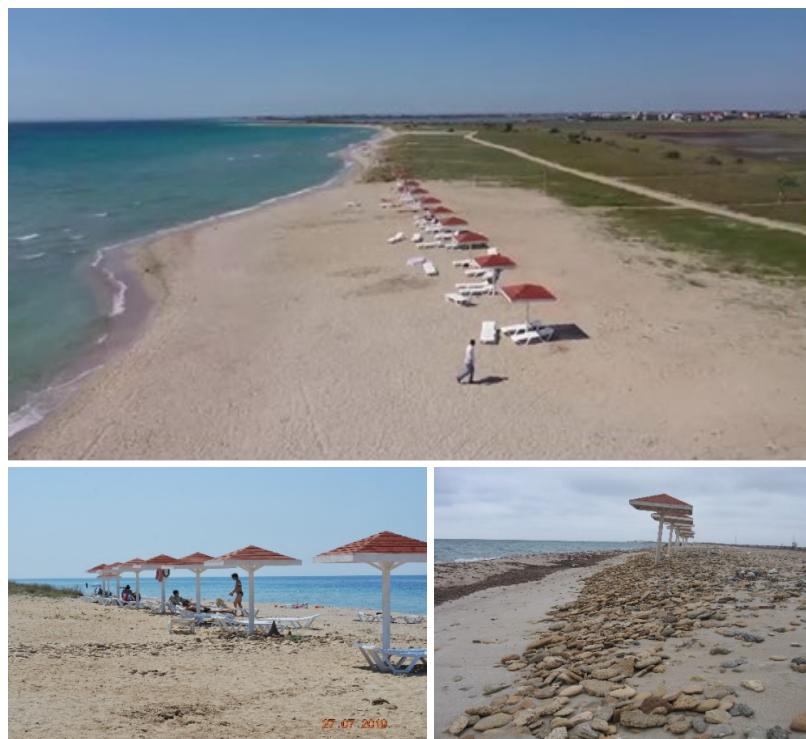
Fig. 7. A beach near the village of Shtormovoye after grading its natural relief (top), the same beach before a storm (bottom left) and after the storm (bottom right)

Particular concern is raised by the increasing anthropogenic impact on the bay-bar beaches, especially the practice of levelling the beach relief for the purpose of beautification, which involves the destruction of dunes. This results in adverse changes in the composition of the beach sediment and its reduction, which is clearly seen in Fig. 7.

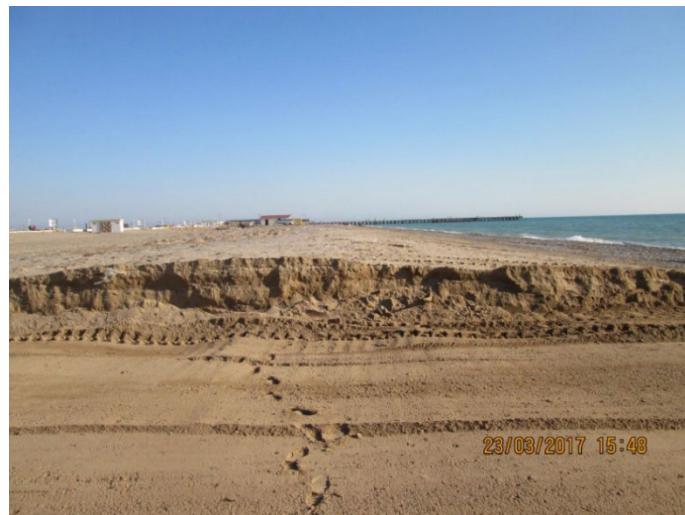
Fig. 8. Grading of the full-profile beach relief at the Sasyk-Sivash Lake's bay-bar
